# 2 ISC

Published by the Victorian  
Government Department of  
Sustainability and Environment  
Melbourne, August 2005.

In 1999, the Victorian Government, in conjunction with its Catchment Management Authorities (CMAs) benchmarked the environmental condition of Victoria's major rivers and tributaries. This was an important milestone for two reasons. It was the first complete and comprehensive study of the environmental condition of rivers anywhere in Australia. Second, the benchmark was based on the first integrated measure of river condition – the Index of Stream Condition (ISC). Before the Victorian benchmarking exercise, river health was assessed by considering single features such as water quality or aquatic macroinvertebrates. These measures focused only on very narrow individual elements of a river and could not convey a total picture of the overall environmental condition.

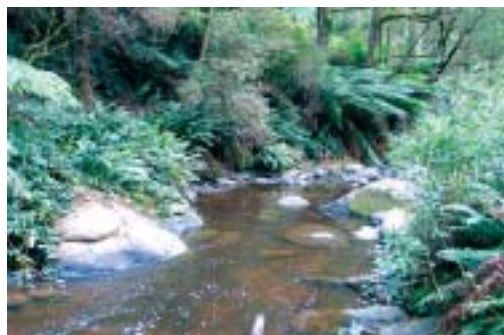
**Basin 35 reach 16 Gellibrand River**  
– Good condition

**Streamside Zone** in near reference condition

**Water Quality** is good but with elevated total phosphorus

**Aquatic life** at reference condition

The individual ISC results for all reaches, for both 1999 and 2004, are available on the Internet, as part of the Victorian Water Resources Data Warehouse ([www.vicwaterdata.net](http://www.vicwaterdata.net)). Information for each reach includes the scores for each sub-index, photographs of the sample sites and all the raw data. An example follows that demonstrates what information is available from the web site for an individual reach:

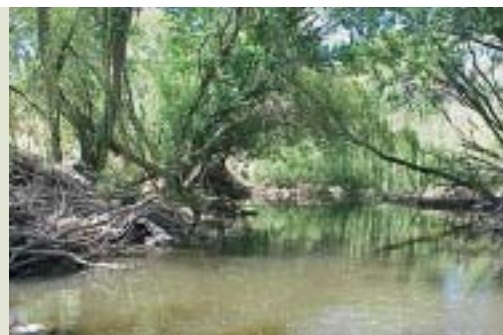
**Basin 23 reach 9 Tambo River**  
– Poor condition

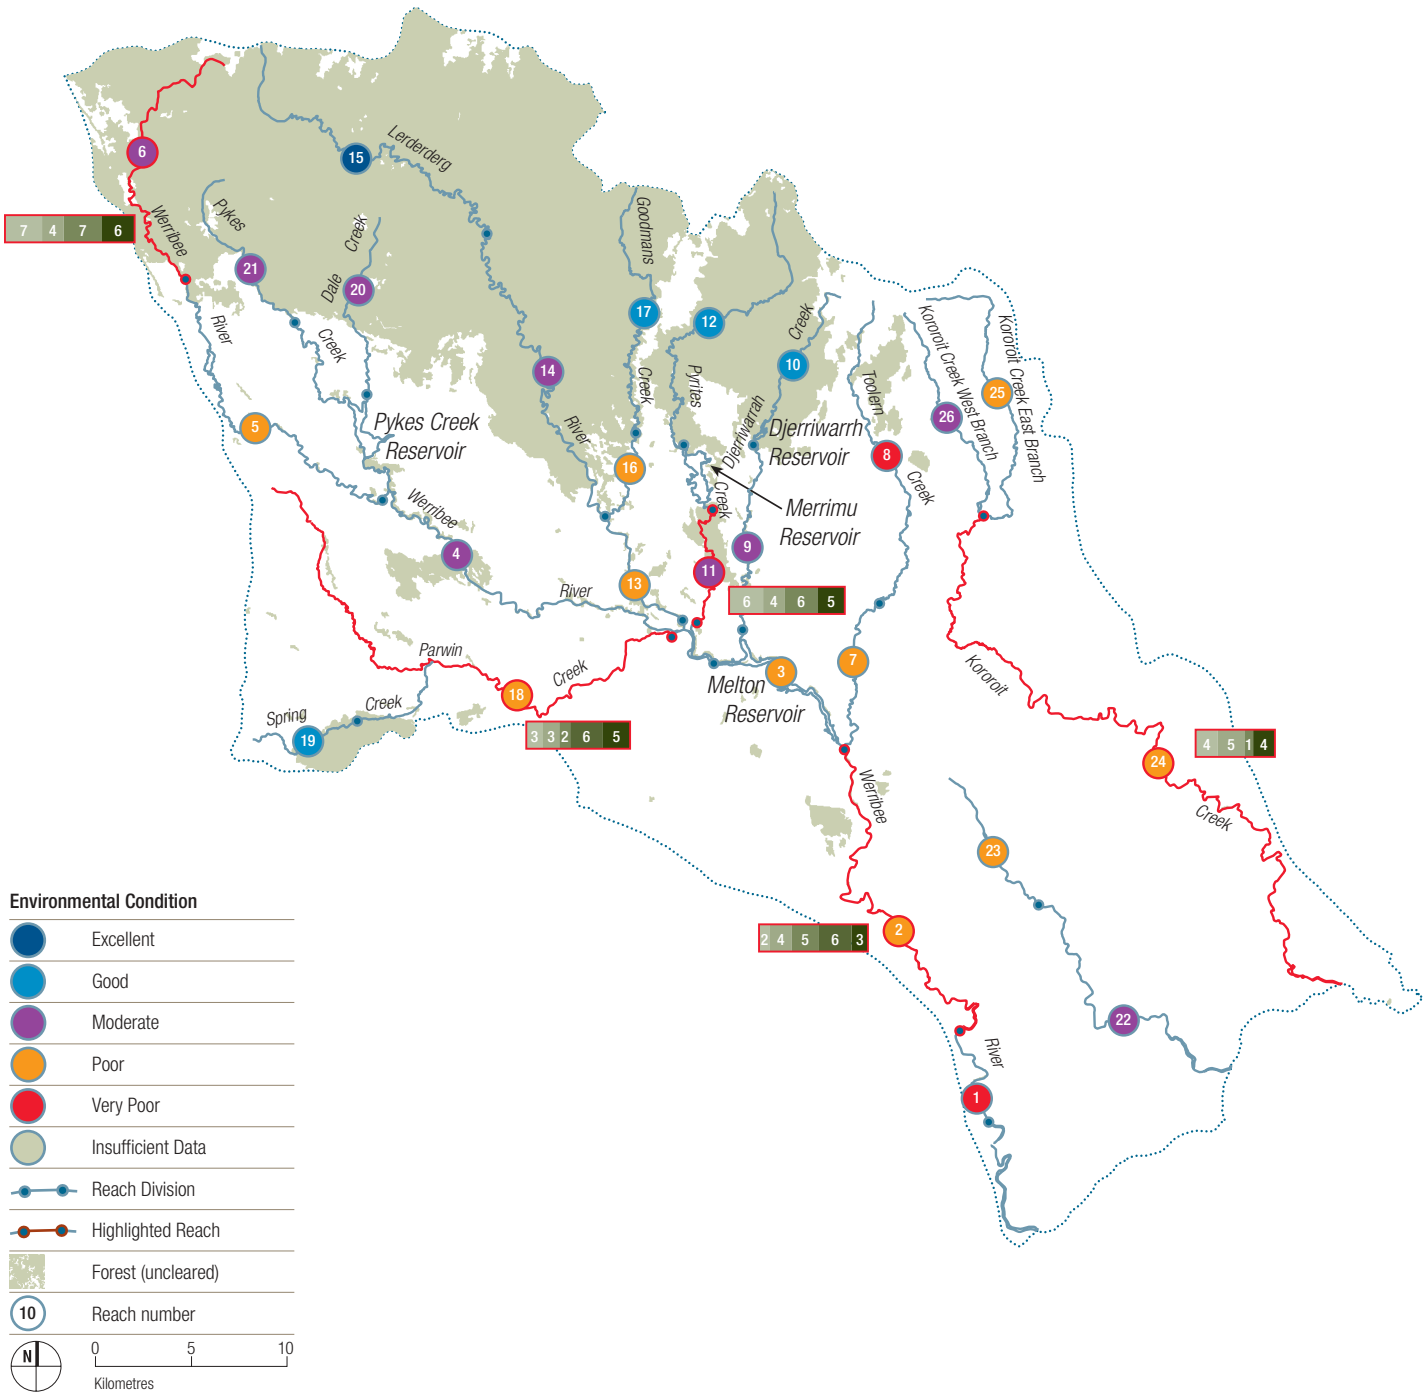
# Basin 31 Werribee

Highlighted Reaches

Most of the basin was in moderate to poor condition (36% and 39% respectively), reflecting the impact of highly regulated flow regimes and highly developed land. The 19% of stream length in good or excellent condition was confined to headwater streams, mainly in the vegetated northern corner of the basin.

Four of the basin's 26 reaches were assessed for water quality. Conditions ranged from poor to very good. Reach 15 on the upper Lerderderg River had the best water quality. Reaches in cleared agricultural areas had poorer results – for example, elevated total phosphorus levels at reaches 2 and 7 and elevated salinity levels at reaches 7 and 18.

The condition of the streamside zone varied widely from heavily modified to near reference condition. Like results for hydrology and water quality, reaches in the forested northern part of the basin were in good to excellent condition. In contrast, reaches in the south and east of the basin scored poorly, consistent with the highly developed surrounding land. In particular, a number of creeks (including Parwin, Kororoit and Skeleton) had little or no quality native vegetation remaining.

Results for physical form were generally poor – no reach was assessed above moderate condition. Stream banks showed moderate levels of instability. A number of barriers restricted fish migration. Quantities of large wood in all reaches were poor except for three forested reaches (reaches 6, 12, and 21).

Almost half of the basin's reaches were assessed for aquatic life. The Werribee River below Bostock Reservoir (reaches 2, 3 and 5) was in the poorest condition. Generally, poorer scores were recorded in cleared reaches. The highest scores were recorded at the headwaters of the Lerderderg River (reach 15) and at reach 4, a section of the Werribee River, in an isolated pocket of forest. Both these reaches were near reference condition.
