# Index of Stream Condition

The Third Benchmark  
of Victorian River Condition

**ISC3**

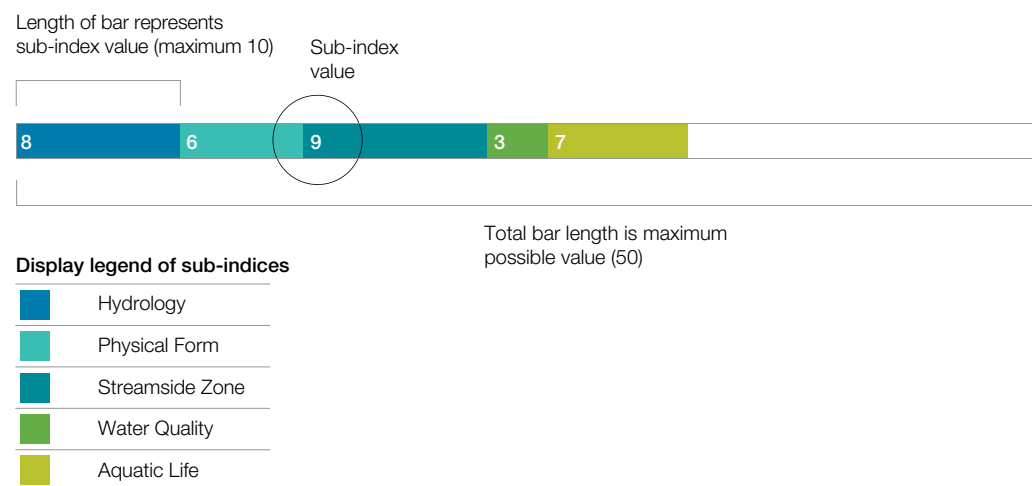
**Figure 2: The ISC bar showing the 5 sub-indices**

The ISC score for each river reach is presented as a bar graph of the five sub-indices, as shown in Figure 2.

Each river reach assessed is given an overall ISC score of between 0-50. This score is then categorised into one of five broad condition bands – excellent, good, moderate, poor or very poor. It is important to emphasise that while the condition band is useful in summarising the overall condition of a river reach, it is the details (sub-index and metric scores) that are used to better understand the issues affecting the condition of a reach and are used in river planning and management.

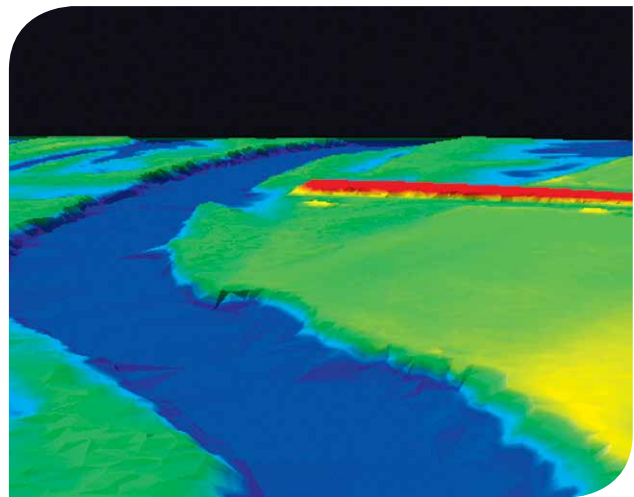
A 3D LiDAR image of the ground surface with the vegetation and built structures (such as bridges) removed. The image is coloured by elevation. The blue is the river channel, the green the surrounding land and the red is an elevated road (the bridge across the river has been removed from this image)

LiDAR stands for Light Detection And Ranging. It is a form of optical remote sensing technology. The LiDAR sensor is attached to a light plane and works by emitting a laser beam of light that detects the light that is reflected back from objects in the landscape. This information is then processed and the light returns are separated into bare ground/ buildings/ vegetation. This allows the creation of a range of very accurate three dimensional (3D) images of the terrain and landscape features.

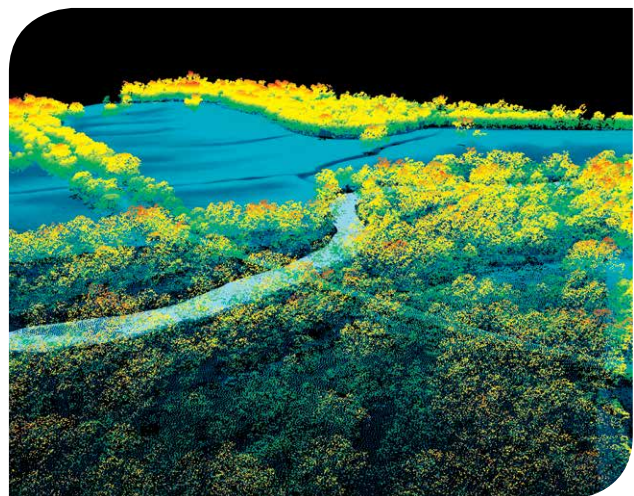
A 3D image of the ground surface showing vegetation generated using LiDAR technology. The different colours are due to the different height of the vegetation (red is taller). This image has not had the road and the bridge across the river removed.

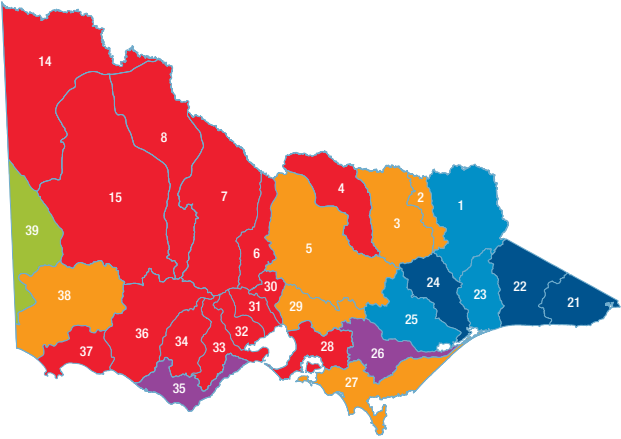
Figure 4: 2010 ISC – Percentage river length in good or excellent condition

The basins in the east of the State had more river length in good or excellent condition compared with basins in the west (see Figure 4). Three basins had at least 70% of their river length in good or excellent condition and include the East Gippsland (basin 21), Snowy (basin 22) and Mitchell (basin 24) basins. This is not surprising as these basins are largely inside National Parks. Another three basins had at least 50% of their river length in good or excellent condition including the Tambo (basin 23), Thomson (basin 25) and the Upper Murray (basin 1) basins. Another two basins have one third of their river length in good or excellent condition (Latrobe (basin 26) and Otway (basin 35)). The largest number of basins (14 basins) had less than 10% of their river length in good or excellent condition and these represent a broad band of basins in the mid-west of Victoria. Typically these basins have been extensively cleared for agriculture.

Comparisons can be done at a two levels – the basin and the reach. Figures 4 and 5 show the basin results for the 2010 and 2004 ISC benchmarks. The two maps compare the percentage of river length in good or excellent condition for each basin. The results are very similar. There was no substantial difference between the 2004 and 2010 results, despite the fact that data for the 2010 benchmark was collected over six years that coincided with the severe Millennium drought (from 1997-2009). It is likely that rivers and streams that are in good or excellent condition are fairly resilient and able to withstand prolonged periods of drought.

Whilst the two statewide maps (Figures 4 and 5) appear similar, they are not the same. There are changes in six basins. These changes are due to four broad reasons:

- changes in the Werribee basin (basin 31) were due to the 2010 score being within 1% of a condition band boundary. In the 2010 benchmark, 10% of stream length was in good or excellent condition which meant the basin was coloured red. If 11% of stream length had been in good or excellent condition, then the basin would be coloured orange, the same result for the 2004 benchmark.

- the Thomson (basin 25) and Glenelg (basin 38) basins improved due to the way the Hydrology sub-index was assessed. Both basins had reaches with priority watering actions. This meant that the Hydrology sub-index scores are a mix of comparisons against management targets and reference condition.

- four reaches (reaches 1,2,4 and 5) in the Kiewa basin (basin 2) on the Kiewa River (totalling 25% of the river length in the basin) changed condition from good to moderate. This change in condition was due to the condition band boundary issue mentioned above and their poorer hydrology scores due to increases in the duration of low flows and changes in flow seasonality.

- Millicent Coast basin (basin 39) did not have sufficient data to allow the condition bands to be calculated in 2010.

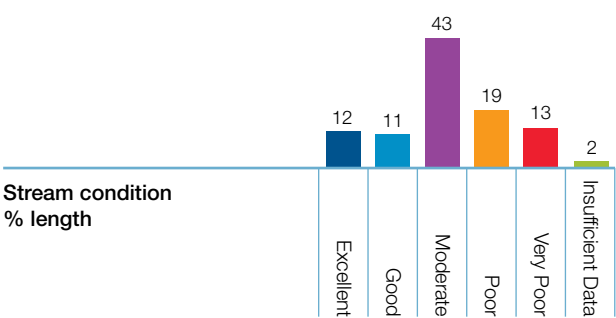
Figure 3: 2010 state wide river condition (histogram)

The 2010 ISC benchmark assessed approximately 29,000 km of rivers and streams. Figure 3 shows that 12% of river length was in excellent condition, 11% in good condition, 43% in moderate condition, 19% in poor condition and 13% in very poor condition (2% of stream length had insufficient data to allow its condition to be determined).

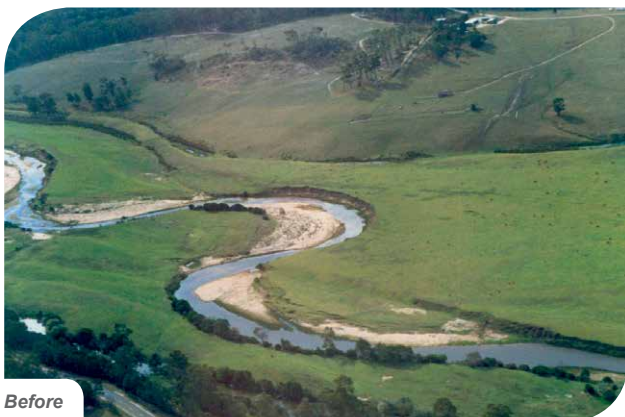
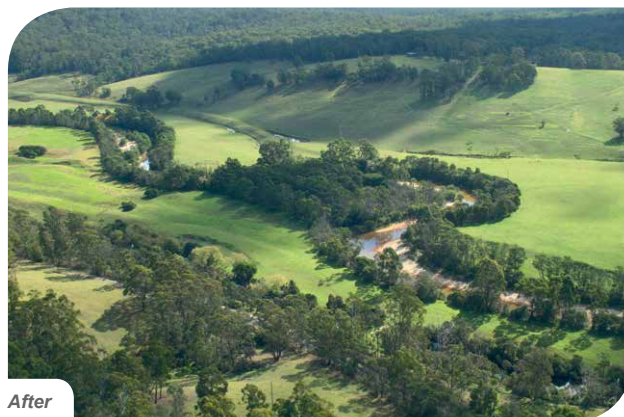
Before

After

The above two photos show the Genoa River before the East Gippsland CMA installed fences and undertook a revegetation program. The two photographs were taken 20 years apart. In East Gippsland, substantial changes in streamside vegetation can be seen in around 5-7 years. In other parts of the state, where rainfall is lower and soils are not as productive, these sort of changes could take 10-15 years or even longer to occur. The photo below shows revegetation of native vegetation after 18 months on the Snowy river.

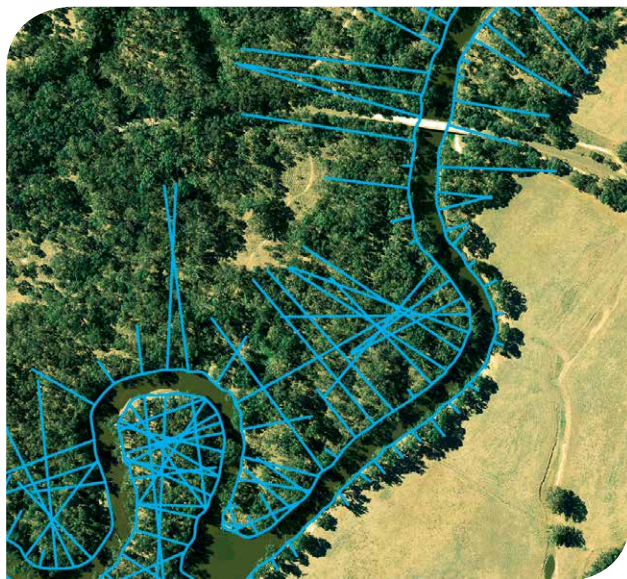
**Figure 6: Width of vegetation on both river banks**

The value of the ISC is not just its ability to summarise river condition data for Victoria at the reach level. Its true value lies in the underlying data. The LiDAR derived metrics for the Streamside Zone and Physical Form sub-indices were assessed at very fine scales (1-2 metre) and were summarised every 100 metres for both the left and right banks over 29,000 km of river length. Figure 6 shows a sample of the vegetation width data generated using the LiDAR and aerial photography.

The length of the line indicates the width of vegetation along the river. Vegetation width was assessed every 25 metres along the river (therefore the lines in the diagram are 25 meters apart). The longest lines represent a vegetation width of 200 metres. This illustrates the level of variability of streamside vegetation width along a stretch of river and the difference that can be encountered on opposite river banks.
